Manhole Inspection Summary

Manhole # S25I__004MH

Insp Date: **3/13/08 11:43 AM**

Location Address: **1224 West Lombard** Cross Street: **South Stockton**

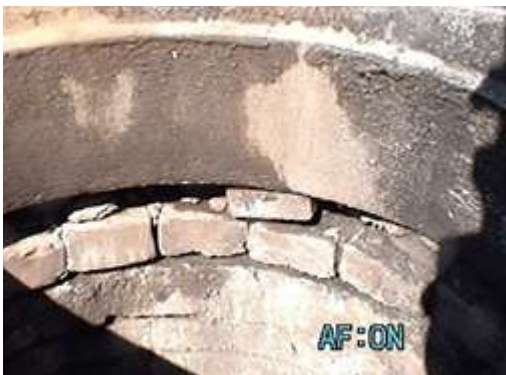
Defect 5

Condition: ☐ Sound ☐ Cracked ☐ Root Intrusion ☒ **Loose Brick** ☒ **Deteriorated**

Loose or missing bricks and mortar in chimney

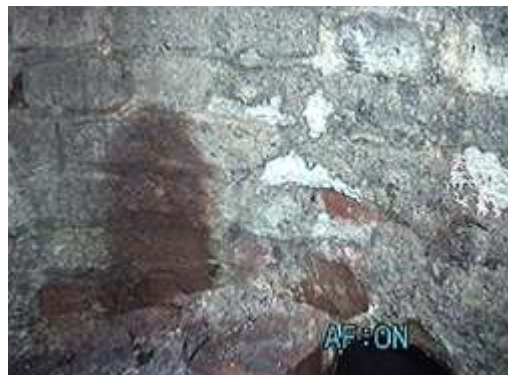
Defect 4

Infiltration: ☐ None ☐ Joint ☐ Cracks ☐ Mortar ☐ Roots ☒ **Wall**

infiltration of the barrel

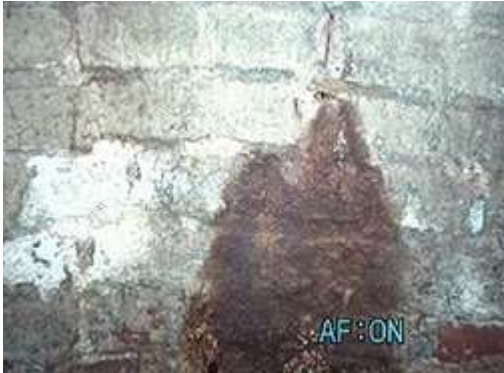
Defect 3

infiltration of the barrel

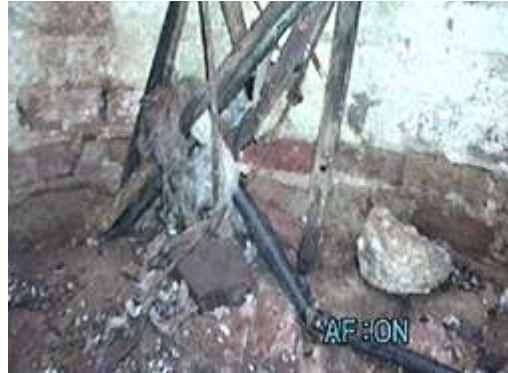
Defect 2

Condition: ☐ Sound ☐ Cracked ☐ Root Intrusion ☐ Deteriorated ☐ Leaks ☒ **Debris**

Debris on bench

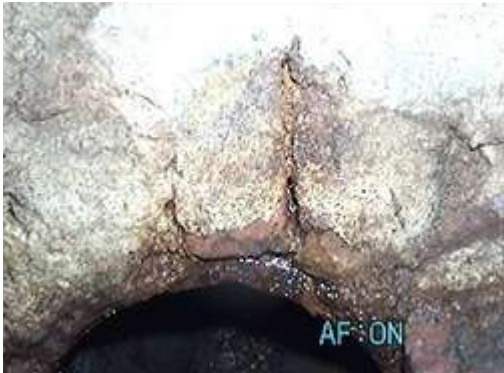
Defect 1

Condition: ☐ Sound ☒ **Cracked** ☐ Root Intrusion ☐ Loose Brick ☐ Deteriorated

crack above the seal of the 6 oclock

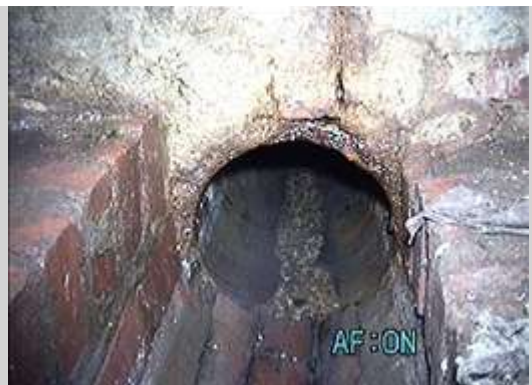
6 O'Clock Inflow

Infiltration: **Evidence** Pipe Seal Cond: **Cracked**
